by B.K. Rastogi

Ground deformation study of M_w 7.7 Bhuj earthquake of 2001

National Geophysical Research Institute, Hyderabad-500007, India, E-mail: postmast@csngri.ren.nic.in; brastogi@yahoo.com

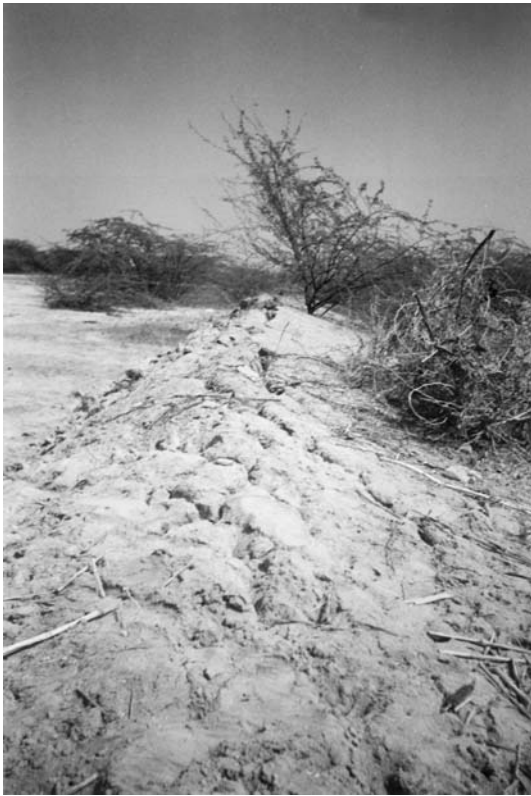
Photograph 2 Land uplift by about a meter near Budharmora.

Ground uplift was observed in Budharmora about 13 km west of the epicenter (Figure 3). Along a length of 300 m in E-W direction and a width of 2–3 m the south side was uplifted by over a meter on a nearly flat ground (Photograph 2). In a field near Bhrudia, a 80 m × 10 m zone is uplifted for 80 cm. Several NW trending ground cracks developed in the uplifted portion (Rajendran et al., 2001).

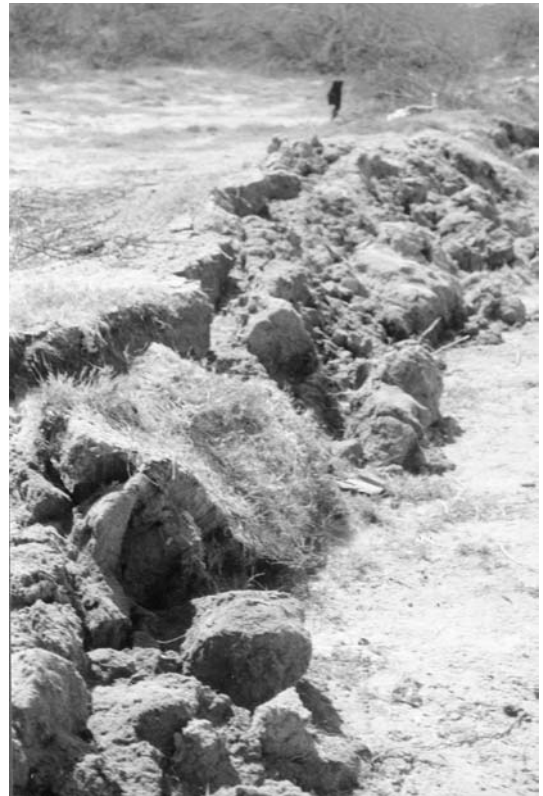
Photograph 3 Another view of the land uplift near Budharmora.

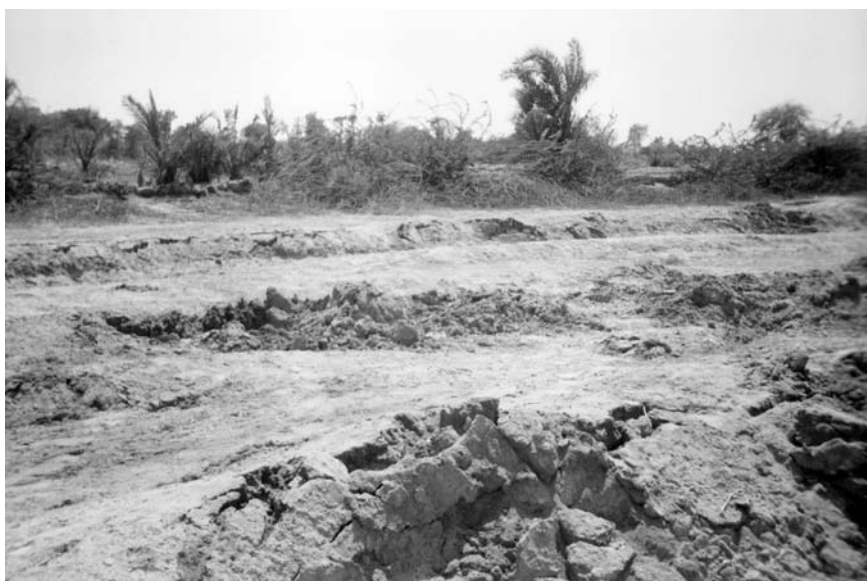
Photograph 4 Step-like lateral spreading in a field a little east of the Budharmora.

The most intense lateral spreading has been observed in the area near Budharmora (Photographs 4 and 5), Chobari, Manfara, Kadol and Khengarpar villa occur in the fields situated along the boundary of Mesozoic and Holocene rocks. Near Manfara the area covered is over 300 m × 400 m. Cracks are about a meter wide, 5–10 m

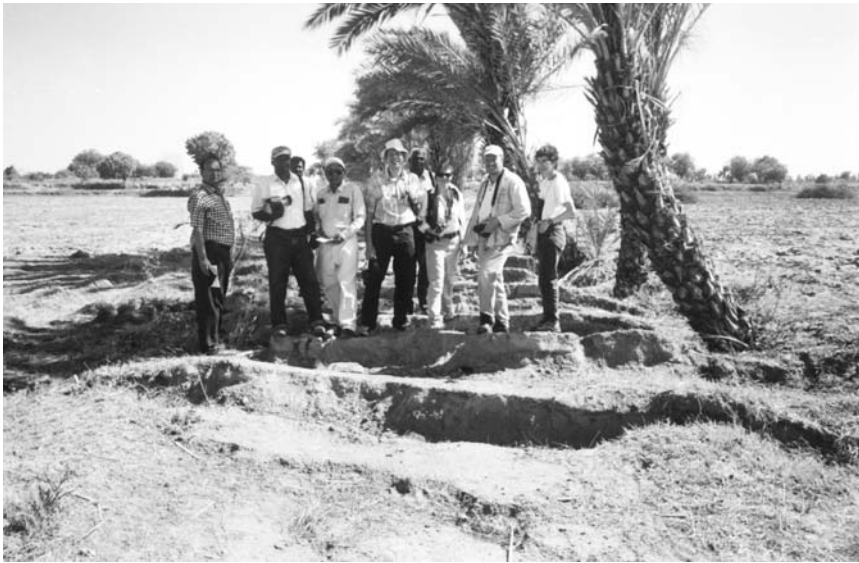
Photograph 5 Step-like lateral spreading on a south sloping road east of the Budharmora uplift.

At a few hundred meters west of Budharmora uplift, a zone of spectacular lateral spreading has been observed in the fields and along a kutchha road. This road is running N-S and at one place where it is sloping southward, step faulting occurs with south side always remaining up (Photograph 5).

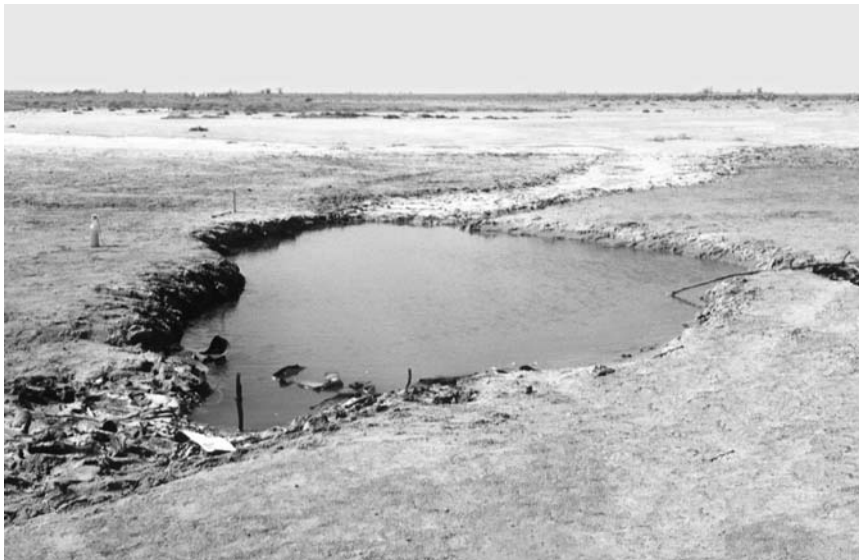
Photograph 6 Big sand craters of 3m diameter formed due to liquefaction near Lodai.

Several instances of sand blows and fluidization have also occurred (Photographs 6 and 7). Lateral spreads and down slips have

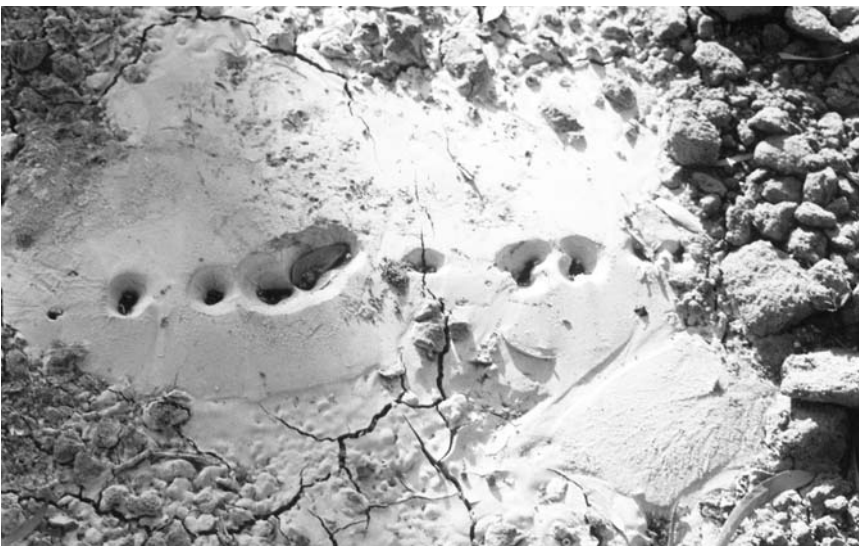
Photograph 7 Small sand craters formed due to liquefaction near Lodai (photo courtesy V. Kolvankar).

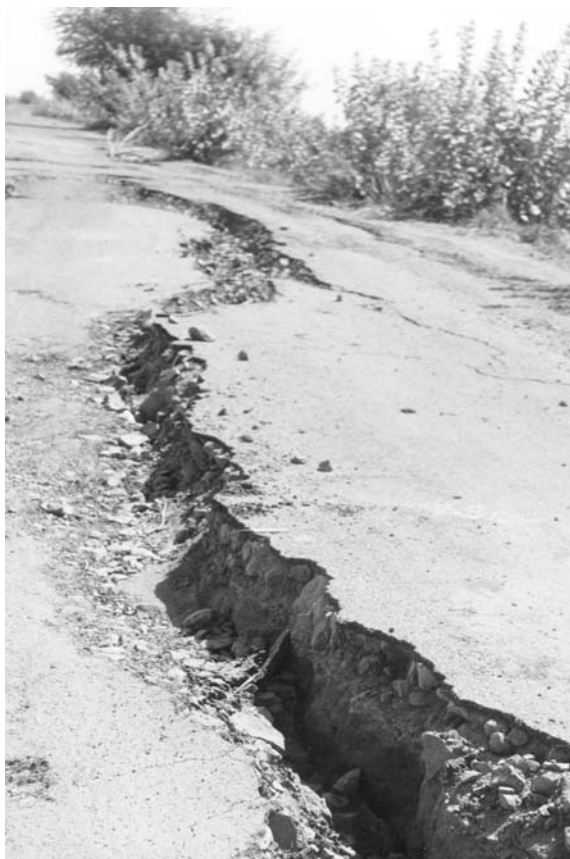
Photograph 8 About 80 cm uplift of the southern side of a road at Chopadwa.

At Chopadwa, lateral spread is observed along an E-W running road where the south side ground has uplifted by about a meter (Photograph 8) and west-side sloping road shows lateral spread.
